EAGLE
Environmental, Inc.

**RE: Pre-Renovation/Demolition Hazardous Building Materials Inspection Report
Former Town Garage
1 Main Street
East Haddam, Connecticut
Eagle Project No. 18-144.10T2**

On June 20 and 21, 2018, Eagle Environmental, Inc. (Eagle) conducted a hazardous building materials inspection of the structure Former Town Garage located at 1 Main Street in East Haddam, Connecticut. The scope of the hazardous building material inspection included an asbestos-containing materials inspection, a lead-based paint screen, lead waste characterization sampling and analysis, a visual inspection for PCB containing materials and an inspection for universal waste materials. The inspection was performed to support the demolition of the building.

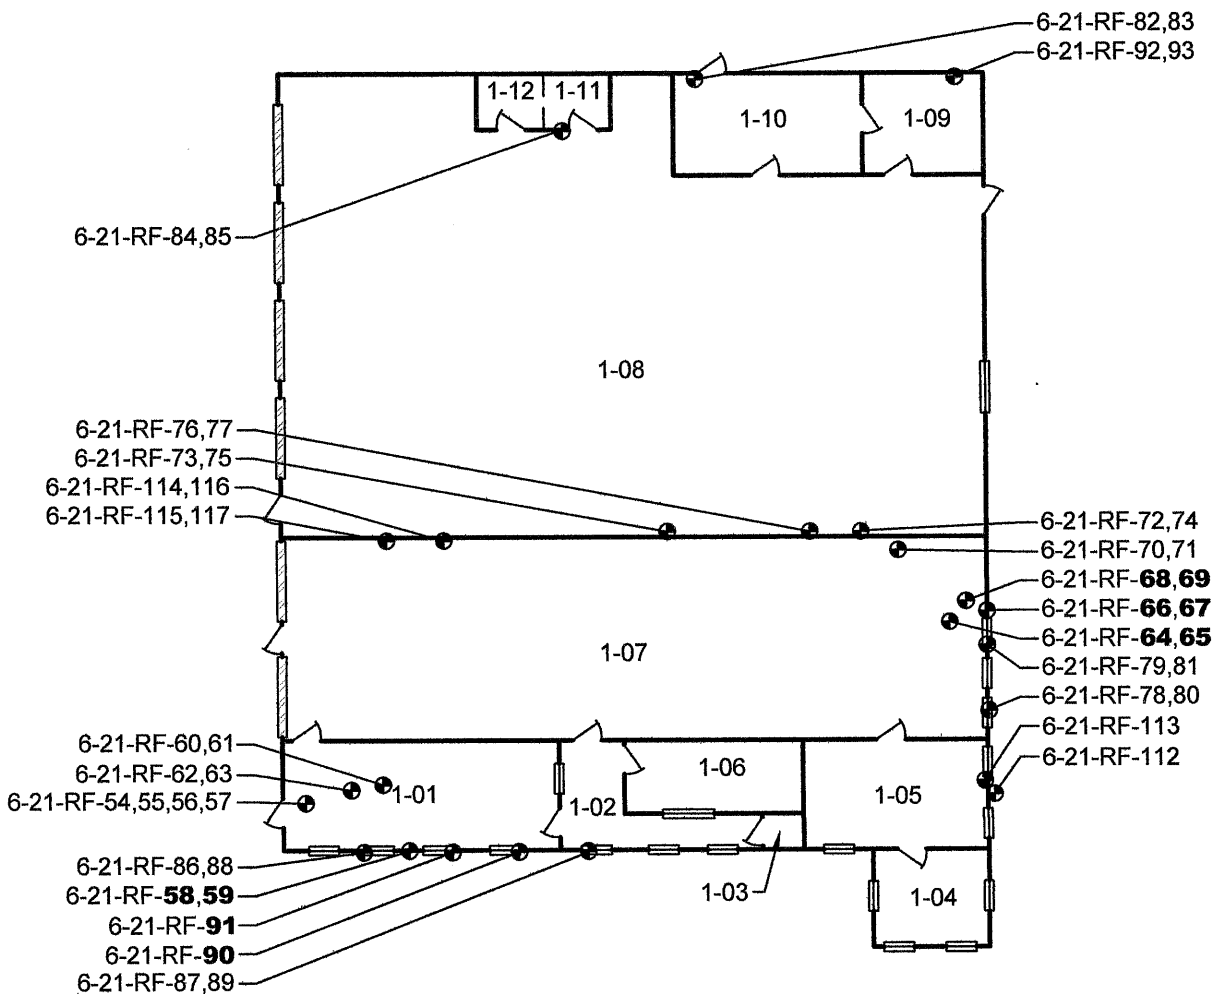
GROUND FLOOR

6-21-RF-## = ASBESTOS
SAMPLE LOCATION
AND NUMBER

BOLDED SAMPLE NUMBERS
INDICATE PRESENCE OF ASBESTOS IN
CONCENTRATIONS GREATER THAN 1%
WITHIN SAMPLE SET.
