**RE: Pre-Renovation Hazardous Building Materials Inspection Report
Former Town Office
7 Main Street
East Haddam, Connecticut
Eagle Project No. 18-144.10T4**

HAZARDOUS BUILDING MATERIALS INSPECTION
TOWN OF EAST HADDAM
FORMER TOWN OFFICE BUILDING
7 MAIN STREET
EAST HADDAM, CONNECTICUT

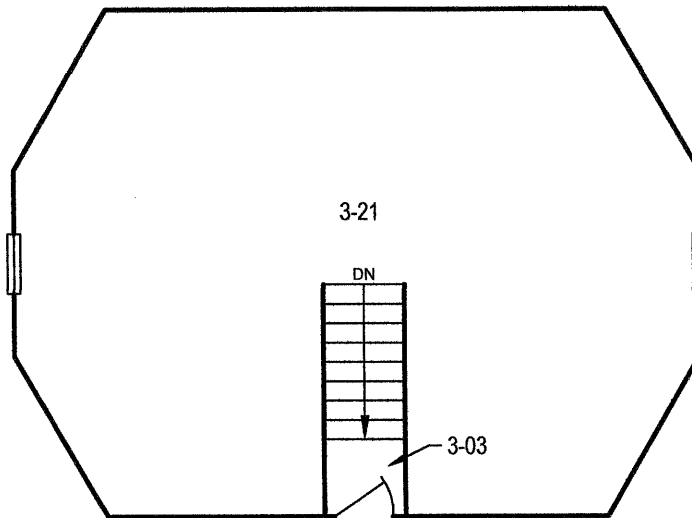
ATTIC
NOT TO SCALE

VAI was identified in the attic with debris assumed to exist in the wall cavities on the floors below. As there is no reliable test to determine the extent of asbestos within this material, Eagle follows the EPA recommendation that the VAI be treated as an asbestos-containing material.
