PHASE I
ENVIRONMENTAL SITE ASSESSMENT
OF
1 & 7 MAIN STREET
East Haddam, Connecticut

MARCH 2002

Town of East Haddam
East Haddam, Connecticut

Shanahan Consulting
Farmington, Connecticut
Document No. 0207R01.WPD

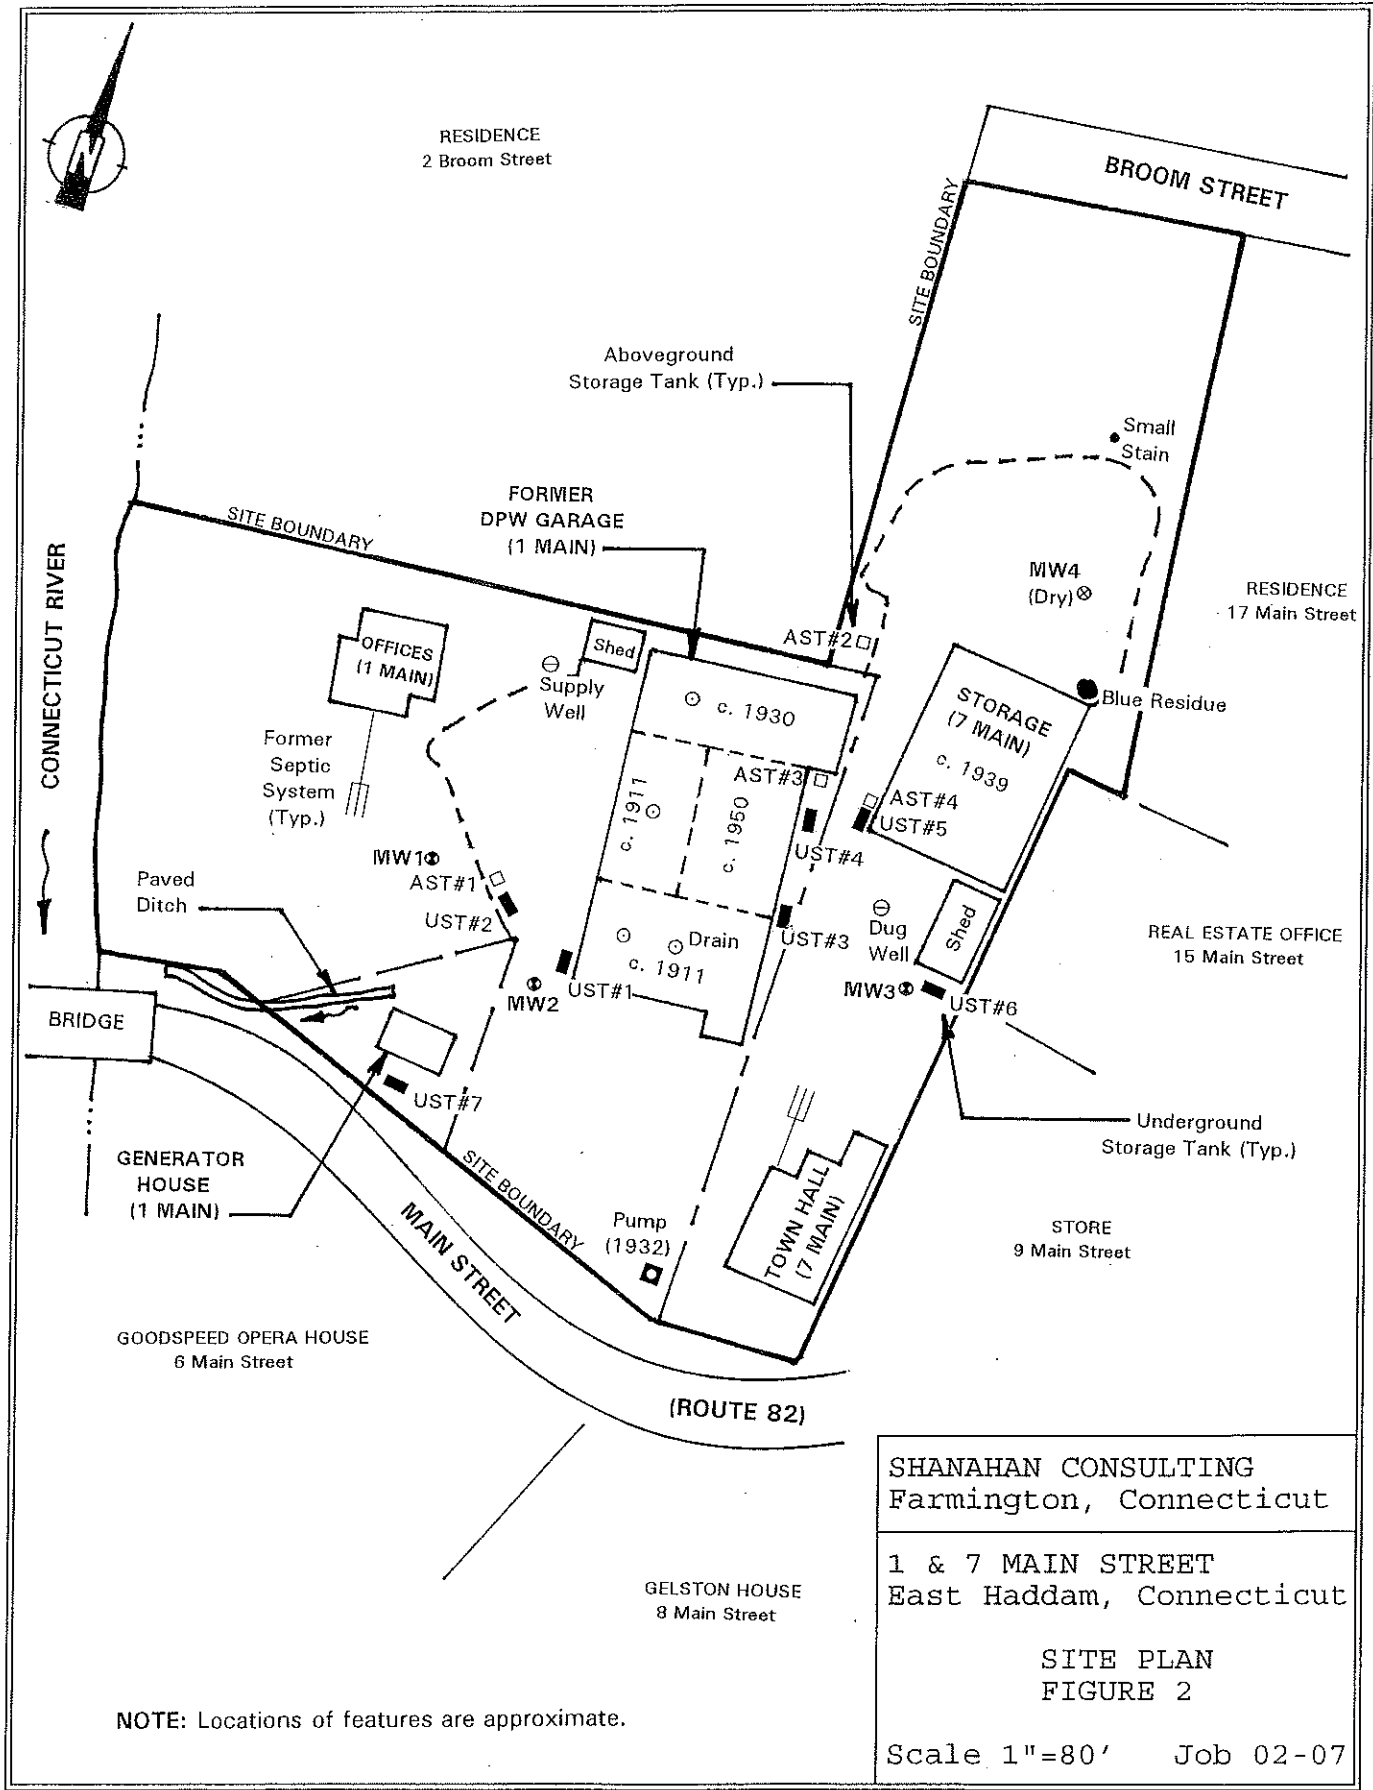
Figure 2 - Site Plan

The garage at 1 Main Street is a one-story structure with no basement that was apparently erected in stages from circa 1911 to circa 1950 (see Figure 2 for approximate dates of construction for various portions of the building). The office building (River House) includes two upper floors and a basement and was erected in circa 1911. The DOT generator house was built in circa 1988 and is one-story in height.

Evidence of former or current petroleum storage tanks on site included: (1) a pavement patch outside the southwest corner of the garage for a reported former underground tank [labeled UST#1 on Figure 2]; (2) two sets of fill and vent pipes for two apparent underground tanks outside the eastern wall of the garage building [UST#3 and UST#4] (the fill and vent for UST#3 was labeled "Fuel #3" on the adjoining wall); (3) a vent pipe outside the southwestern corner of the storage building at 7 Main Street for a possible underground tank (no fill pipe was found) [labeled UST#5]; (4) a metal clip similar to those used to hold tank vent pipes was observed on the southern wall of the shed behind the town hall apparently from the underground gasoline tank removed from this area in January 2000 [UST#6]; (5) a set of fill and vent pipes and two nearby tank monitor wells outside the southern wall of the DEP generator house for the reported underground diesel fuel tank [UST#7]; (6) a set of fill and vent pipes outside the northern wall of the town hall (although the set of pipes were some distance from the wall, they reportedly serve the basement tank in the building); (7) a set of fill and vent pipes outside the eastern wall of the garage which connect to an indoor heating oil tank; and (8) a set of fill and vent pipes protruding from the eastern wall of the River House which serve

The former Connecticut DOT bridge maintenance garage at 1 Main Street (circa 1911 to 1973) included garage repair bays, a machine shop, a blacksmith shop, and paint storage areas. These activities and the reported petroleum storage tanks discussed above suggest the use of the following oils and chemicals: gasoline, heating oil, lubricating oil, paints and paint thinners, machine oil, and possibly degreasing solvents. The machine shop was located in the southeastern corner of the garage, while the blacksmith shop was located in the area of the circa 1950 addition (see Figure 2).

We recommend that a magnetometer survey be performed to explore for suspected underground tanks.

Underground tanks identified during our site visit and during the subsequent magnetometer survey should be excavated and removed. Soil samples should be collected from each tank grave (whether or not contamination is observed) and tested in a laboratory to document soil conditions. If contaminants exceed DEP cleanup criteria, then a soil removal program (at unknown cost) would need to be undertaken.
