**PHASE II & PHASE III
ENVIRONMENTAL SITE ASSESSMENT
AND REMEDIAL ACTIONS
AT
PROPERTIES AT 1 & 7 MAIN STREET
East Haddam, Connecticut**

JUNE 2005

Town of East Haddam
East Haddam, Connecticut

Shanahan Consulting
Farmington, Connecticut
Document No. 0417R01.WPD

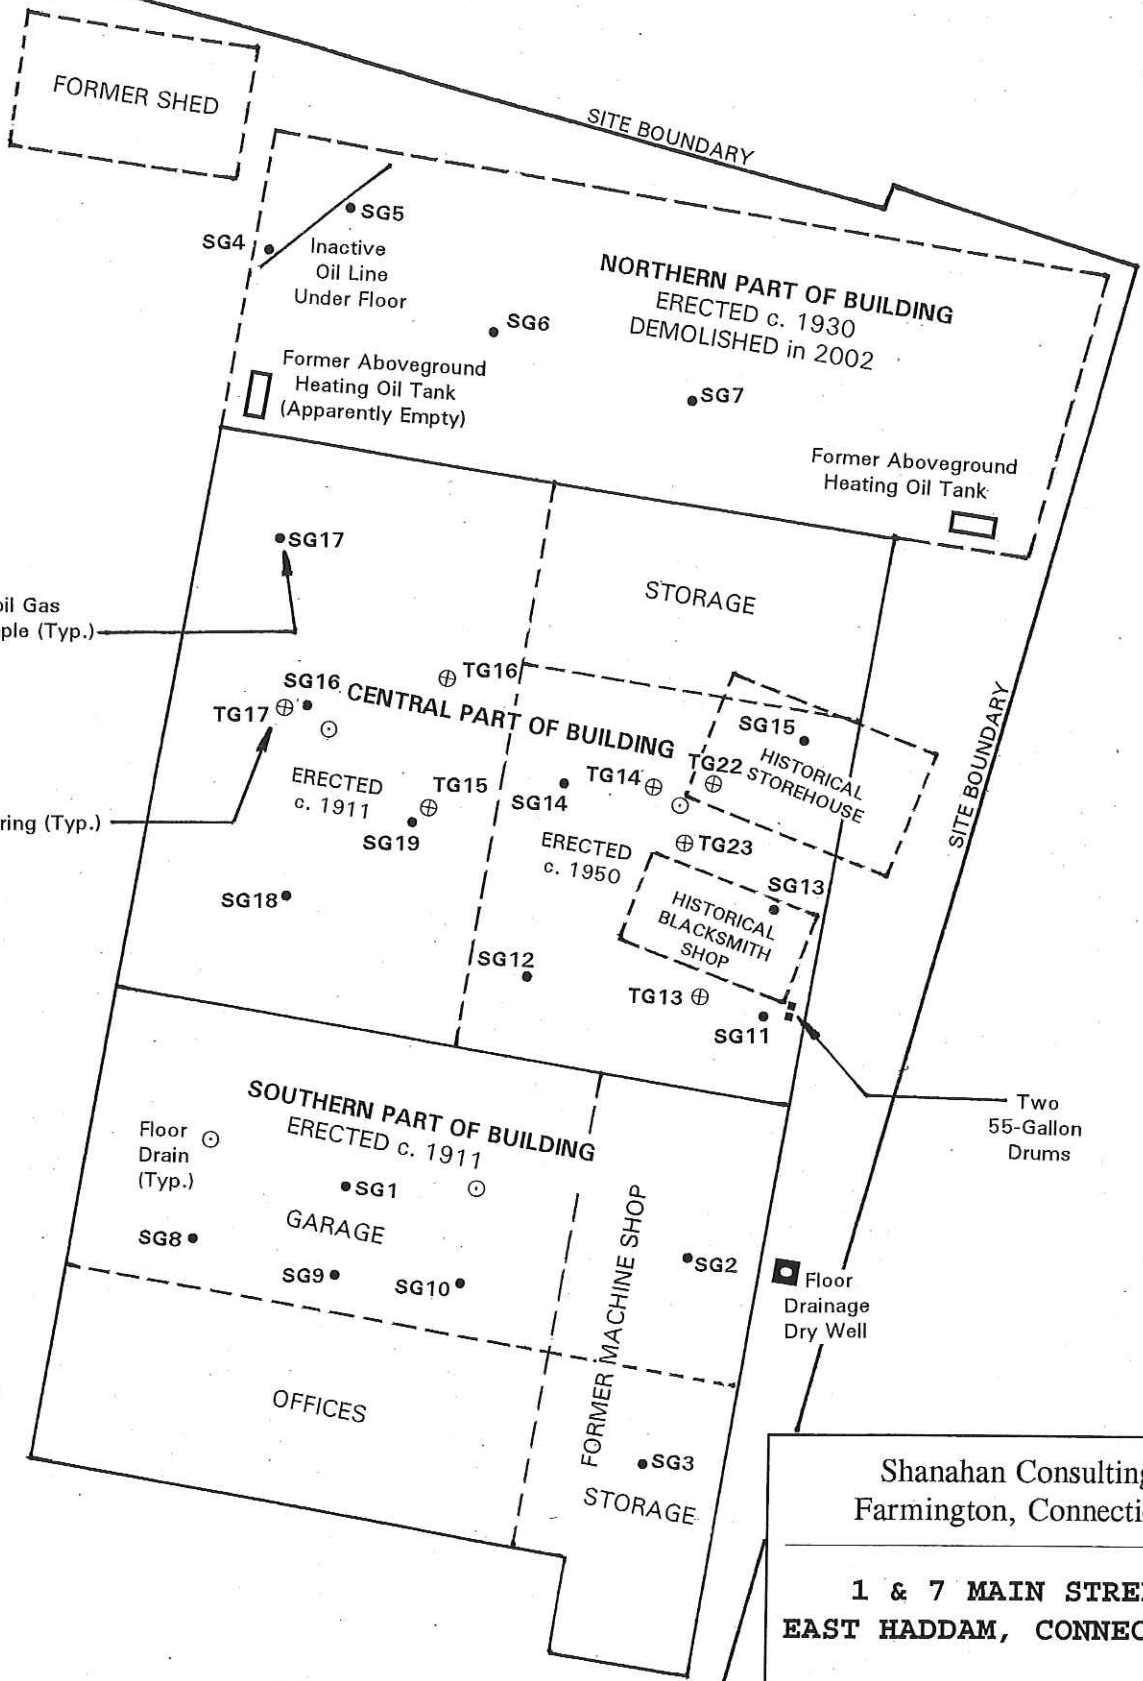
**EXPLORATIONS UNDER GARAGE
 FIGURE 5**

The concrete slab floor ranged in thickness from approximately 6 to 8 inches and was in good condition. Appendix E describes the exploratory work performed by Hygenix and Figure 5 shows the approximate locations of the sampling points (as well as subsequent soil borings drilled through the garage floor to collect soil samples [borings discussed later in this report]).

No VOCs were detected in the southern and northern parts of the garage. The southern area where no PID responses were noted included the former machine shop area (SG2 and SG3). In the central section of the building, seven locations (SG12, SG14-SG19) exhibited positive PID readings using either the 10.2 eV or 11.7 eV instrument. The VOC concentrations at location SG19 were significantly higher than any other reading. The soil gas detections guided our subsequent drilling program under the garage floor, as is discussed later in this report.

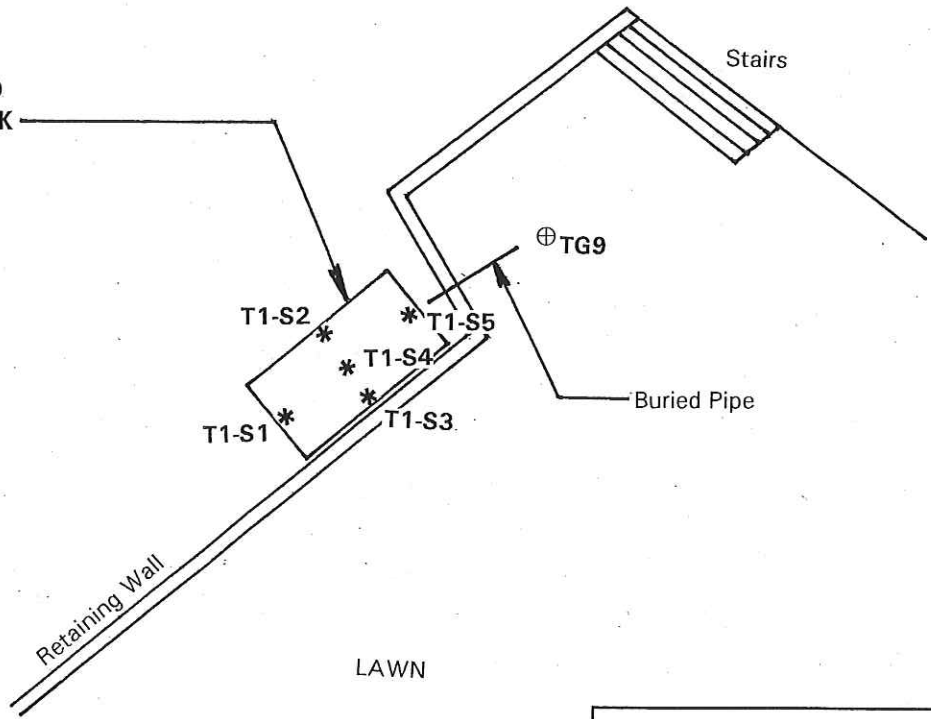
**UNDERGROUND TANK REMOVAL
WEST OF GARAGE
FIGURE 7**

We observed no evidence of a release during the removal of the 500-gallon gasoline tank west of the garage, which appeared to be quite old (it was shown on a 1925 Sanborn Map). The tank contained remnant gasoline. The grave measured approximately 9½ feet long by 5 feet wide by 5½ feet deep (the depth was measured in reference to the ground surface on the north, south, and east sides of the grave; a one-foot-high retaining wall on the west side of the grave increased the relative depth to 6½ feet from this side of the grave). No ground water was observed in the tank grave.

Two metal pipes were observed to be exiting the grave to the south. One of the pipes was of short length and was removed by the excavator. The second pipe (of unknown purpose) could not be removed without endangering the retaining wall on the southern edge of the tank grave. We elected to explore in the area of the second pipe during our upcoming test boring program.

The soil test data did not exceed applicable remediation criteria. The absence of aromatic VOCs in the samples appeared to confirm our field observations that the tank had not leaked.

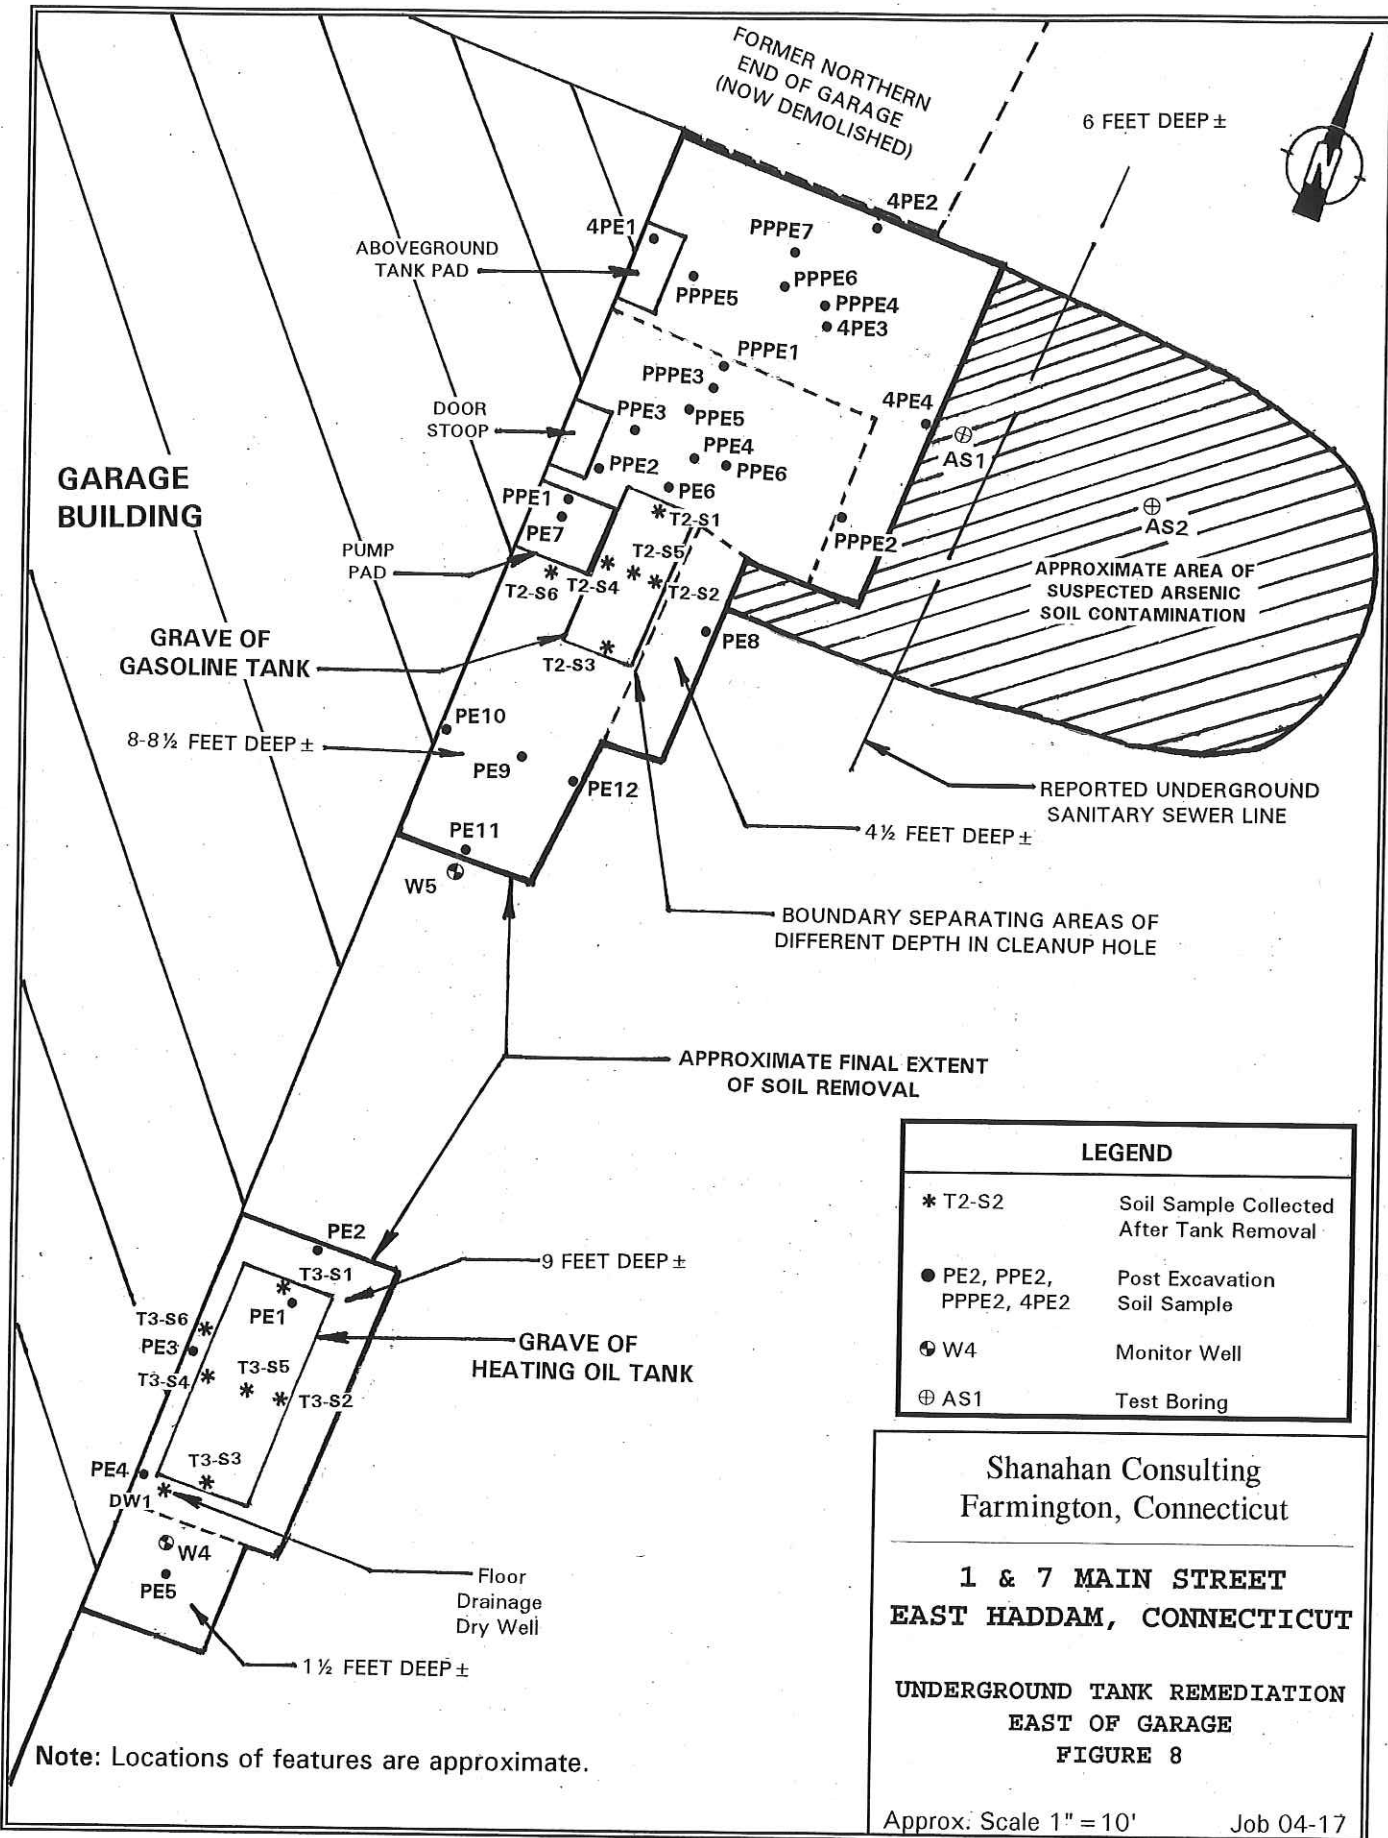
The tank grave measured approximately 9½ feet long by 4 feet wide by 5½ feet deep. No ground water was observed in the grave. Soils at depth near the southern end of the grave appeared to exhibit petroleum odors. Surface soils in the area (particularly near the pump pad) exhibited petroleum odors (apparently due to spills at the pump or during the re-fueling of the tank).

The 1000-gallon underground heating oil tank was located approximately 35 feet south of the eastern gasoline tank. The grave of the tank measured 12 feet long by 5 feet wide by 7 feet deep. Ground water was not observed in the grave. Soil at depth at the northern end of the grave appeared to exhibit petroleum odors and staining. In addition, surface soils around the fill pipe were stained and odorous.

In an attempt to address the soil contamination found at the eastern gasoline and heating oil tanks, Underground Systems returned to the site on 12 & 13 August 2002 to excavate contaminated soils under the observation of Ned Shanahan. Figure 8 depicts the soil removal areas and post-excavation soil sampling at the tanks.

A mixture of contaminated and uncontaminated soils had been placed in the tank grave after its removal in June 2002. Underground Systems removed the soil mixture for off-site disposal. Soil tests performed in June 2002 demonstrated that contaminated soils were present on the ground surface adjacent to the wall of the building (apparently due to fuel overfills) and in the northern end of the tank grave at depth. After removing the soil mixture in the grave, soil was removed from the northern end of the grave and in areas of surface staining. In addition, a small surface stain observed near the southern edge of the tank grave was scraped to a depth of 1½ feet. The soil removal effort was guided by petroleum odors and staining.

The final dimensions of the excavation measured approximately 22 feet long by 9 feet wide and up to 9 feet deep. No ground water was observed in the cleanup excavation, but hand excavation in the base of hole to a depth of 9½ feet revealed wet soils.

After the removal of the contaminated soil, Ned Shanahan collected five post-excavation soil samples (PE1-PE5) on the edges of the removal area. PE1 and PE2 were collected in the northern end of the grave (bottom and north wall respectively) after removing odorous soils at depth. PE3 and PE4 were collected after removing odorous soils in the apparent overfill area adjacent to the building wall. PE5 sample was collected in the area where the small surface stain had been removed south of the tank grave. The soil samples were placed in a chilled cooler and were transported to Connecticut Testing Laboratories for analysis for ETPH and aromatic VOCs by EPA Method 8021B. The two contaminants sought in the post-excavation samples had been detected above remediation criteria in soil tests performed at the time of tank removal.
