GROUND WATER TESTING \mathbf{AT} 1 & 7 MAIN STREET East Haddam, Connecticut

MAY 2006

Town of East Haddam East Haddam, Connecticut

Shanahan Consulting Farmington, Connecticut Document No. 0609R01.WPD

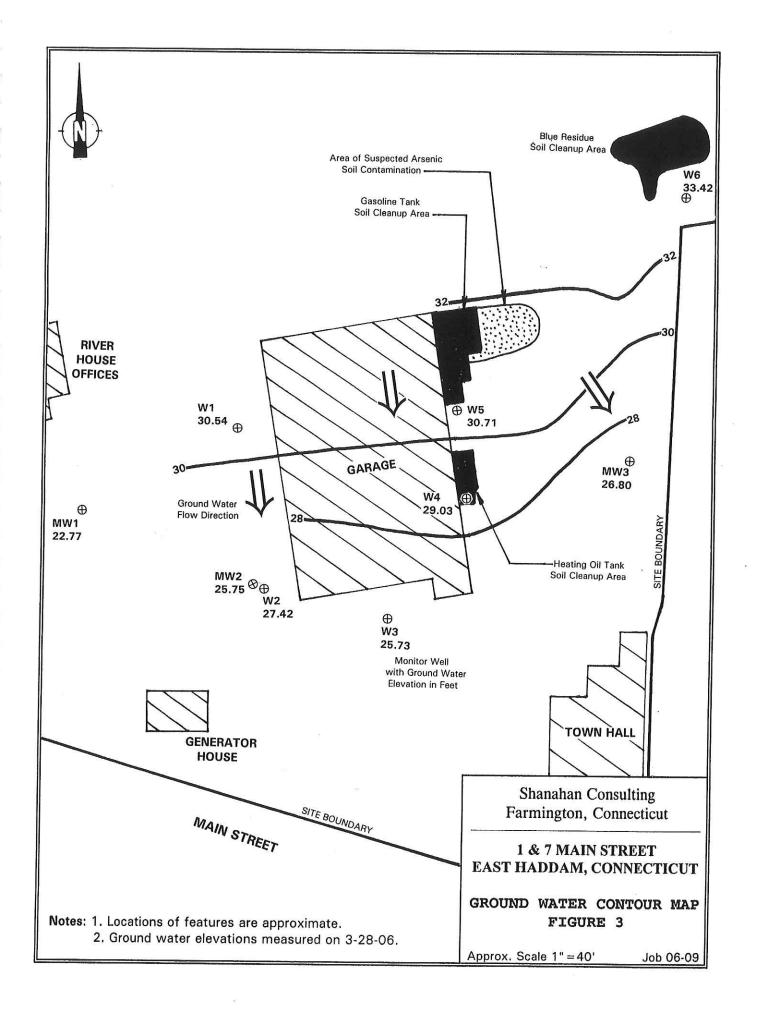
Figure 3 - Ground Water Flow Map

Figure 3 presents an overburden ground water contour map using the data from the seven overburden wells. The contour map indicates that overburden ground water on most of the site flows to the south. On the eastern edge of the site, overburden ground water appears to flow toward the south/southeast.

Overburden ground water was not encountered on the western part of the site where bedrock occurs at shallow depths. The lower elevation of the water table in bedrock well MW2 (25.75 feet) when compared with the adjacent overburden well W2 (27.42 feet) suggests that ground water flows downward (from the overburden into the bedrock) at this well pair.
