RESILIENT EAST HADDAM

FINAL REPORT
CIRCA PHASE III - RESILIENT CONNECTICUT

JUNE 2025

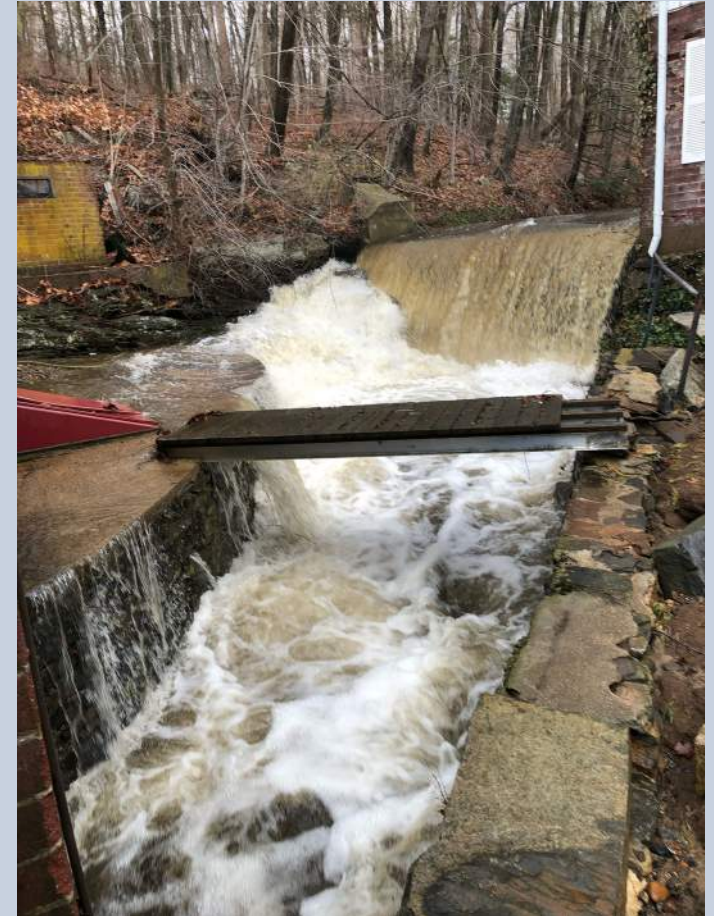
Fast moving water over Trouble Pond Dam, upstream of the Tenney Rehearsal Studio

Kleinfelder found that if Trouble Pond Dam were to be lowered or removed, the impacts on flooding would be negligible given that the Rehearsal Studio culvert (and the Norwich Road bridge downstream of the Studio) controls flooding on Norwich Road in present-day storms. In large mid-century storms, the Norwich Road bridge near Ray Hill Road is projected to overtop, sending floodwaters downhill on Norwich Road towards the low point in front of the Artists Village. Based on field observations, the dam is currently providing little flood storage due to sediment accumulation on the upstream side of the spillway.

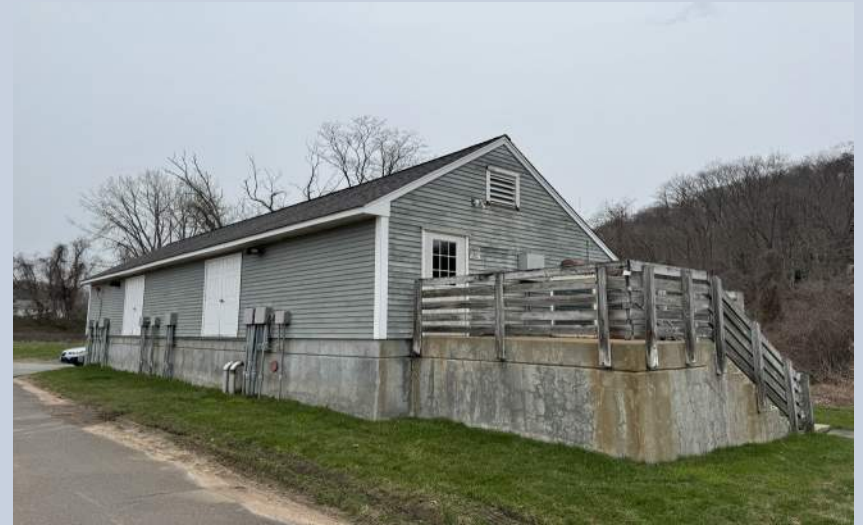
WWTP Process Building

The WWTP consists of two pre-engineered wood-frame buildings, known as the Process and Control Buildings, constructed on elevated concrete foundations. An emergency generator is located on an elevated platform outside the Process Building. The generator is fueled by propane stored in two tanks anchored to a concrete slab behind the WWTP buildings.

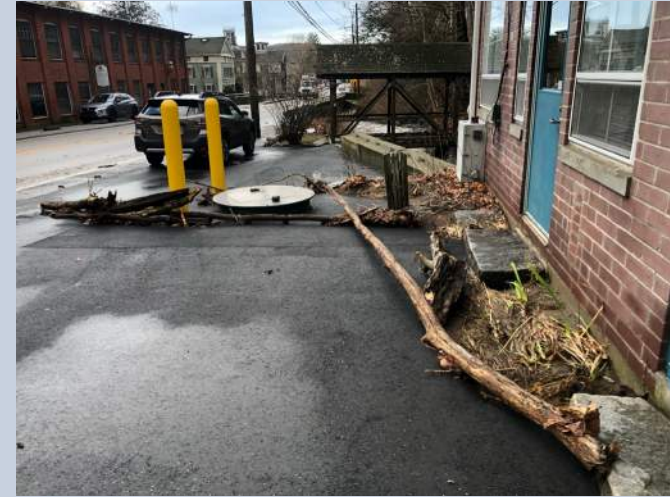
Debris next to rehearsal studio after January 2024 flood

During past floods, the box culvert carrying Succor Brook under the Tenney Rehearsal Studio has become clogged with large debris carried by the Brook, such as logs and tree branches. Debris clogging has contributed to flooding even during smaller storm events, such as the January 2024 flood, during which rainfall approximately equal to the 2-year 12-hour storm was recorded. Additionally, the culvert is aligned at an offset from the spillway of Trouble Pond Dam immediately upstream of the culvert. This arrangement is hydraulically inefficient during high-flow events, as shown in photos and videos of past floods.

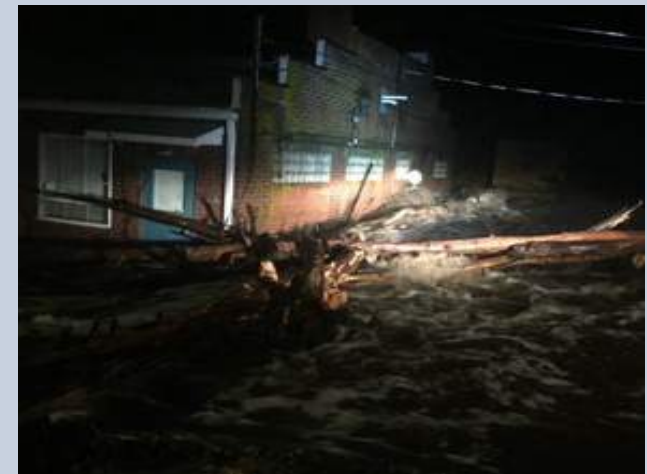
Debris piled up during flooding along Succor Brook

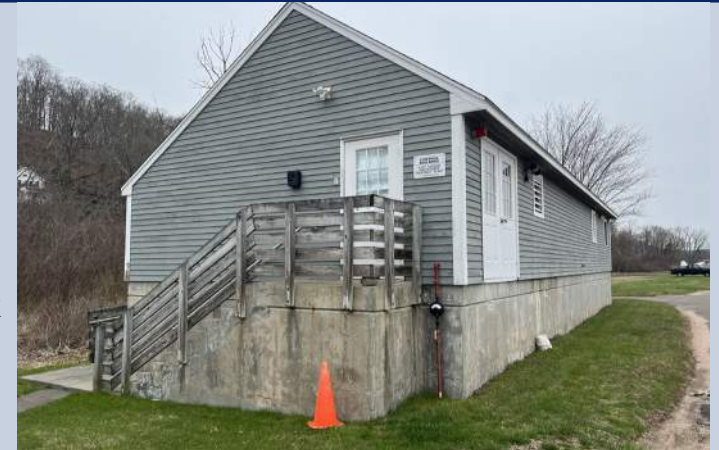
WWTP Control Building

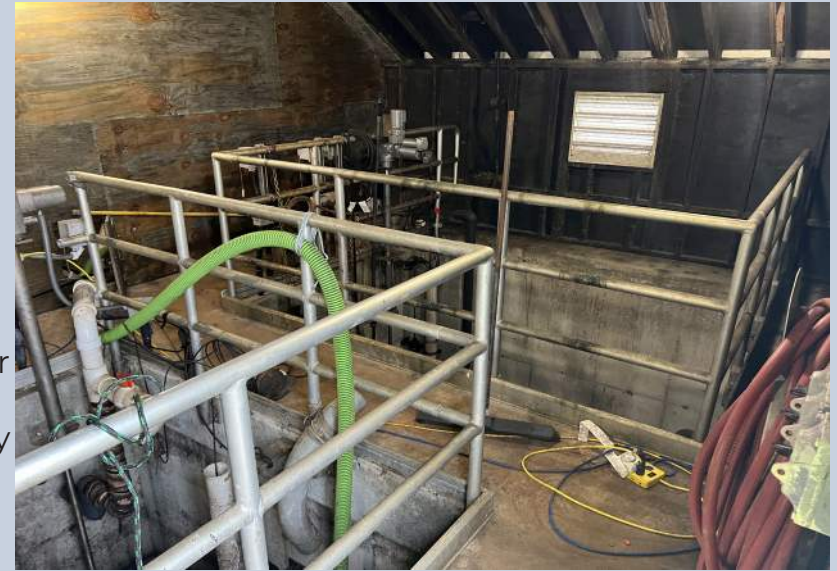
WWTP Process Building Interior

If a 100-year flood were to occur along the Connecticut River in the present-day, approximately 0.2 feet of water would enter the WWTP buildings. This poses a risk of damage to objects stored on the floor and equipment mounted near the level of the floor. One of the WWTP buildings, the Process Building, has reactor tanks used for wastewater treatment that are covered by open metal grating. Floodwaters would be susceptible to entering the tanks via these openings, potentially disrupting the treatment process. In a 2050 100-year flood, there is the potential for 1.9 feet of floodwater to enter the building. This would pose significant risk to the wood-frame structure of the WWTP buildings above their elevated concrete foundation resulting from hydrostatic and hydrodynamic flood forces. Water within the building would reach a level that would inundate the fine screening and ultraviolet disinfection units and all other materials and equipment at an elevation equal to or below 13.9 ft above NAVD88.

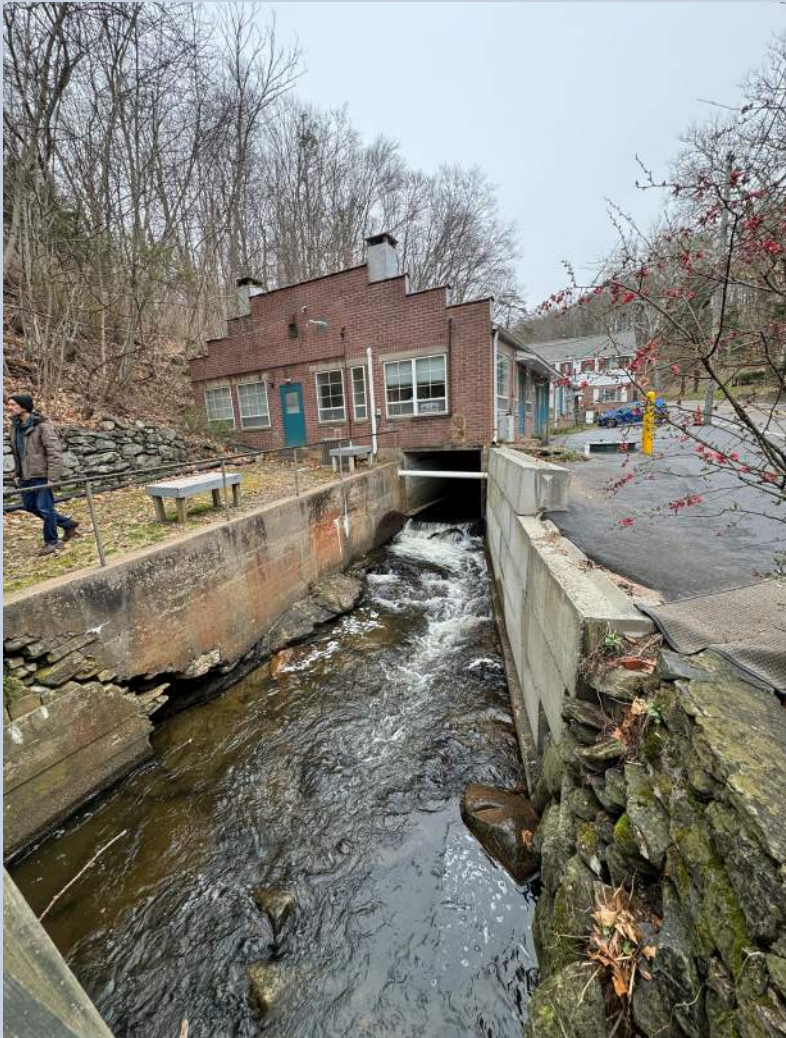
Restored Stream with Rehearsal Space Removed

Before

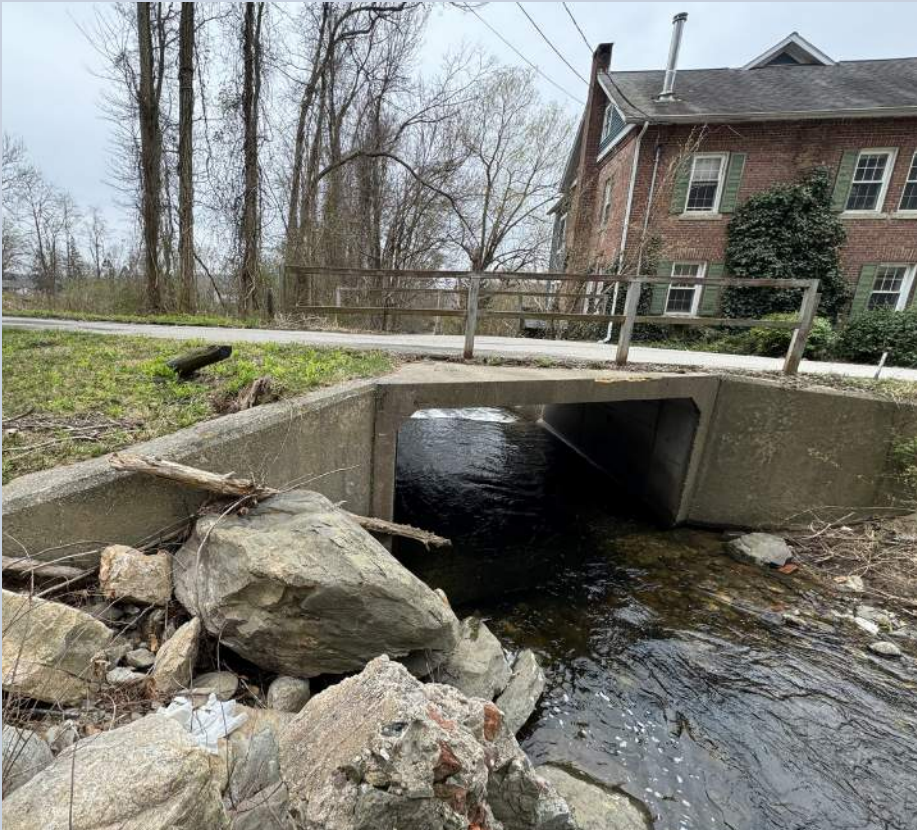
Widened Creamery Road Crossing

Before

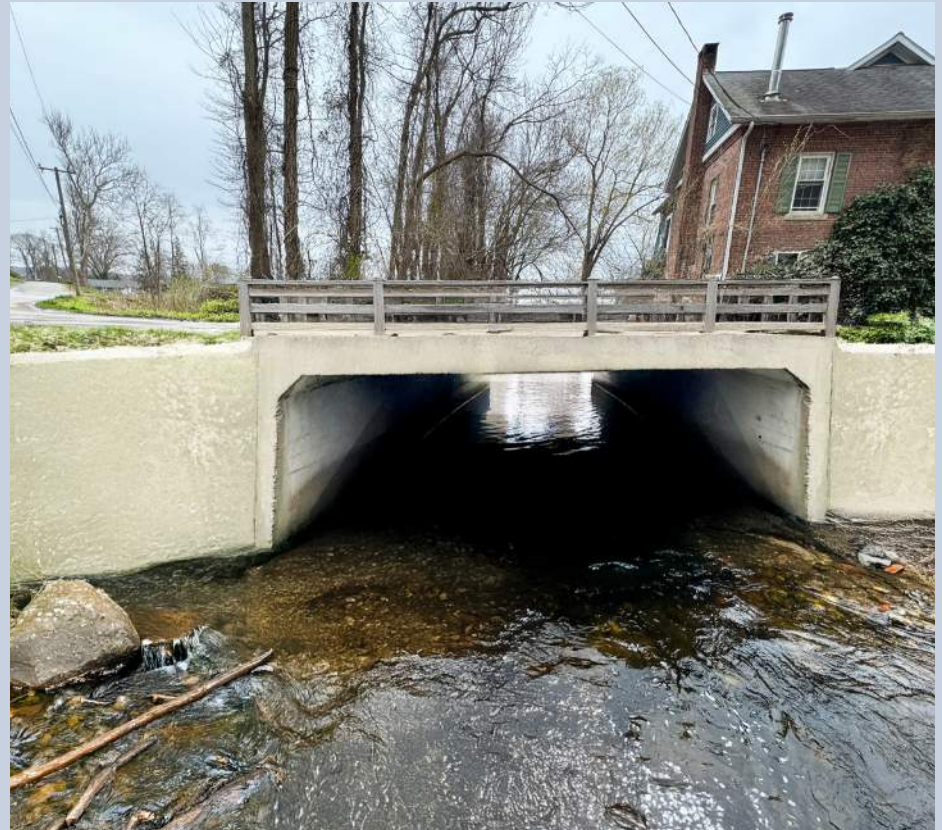
After

Alternative 2 includes Alternative 1, plus replacement of the existing box culvert carrying Creamery Road over Succor Brook with a new, wider bridge that spans the bankfull width of the Brook. Also, this alternative includes an expanded bank on the right-hand side of the Brook upstream of the Creamery Road crossing.

Additionally, the present Creamery Road culvert is a four-sided precast concrete structure, and replacing the crossing with a new bridge presents an opportunity to restore the natural channel in this area. The conceptual replacement bridge would be approximately 24 feet wide, roughly double the width of the existing crossing. Reconstructing the right-side bank of the Brook, which currently is formed by a stone armor edge, could provide new wetland habitat and replicate natural wetland and floodplain function. Modeling of this alternative included a conceptual re-constructed bank extending approximately 300 feet upstream of the Creamery Road bridge. The channel was widened by approximately 10 feet. Sizing of the bridge and expanded bank would be verified in a future design phase should the Town opt to pursue this alternative.

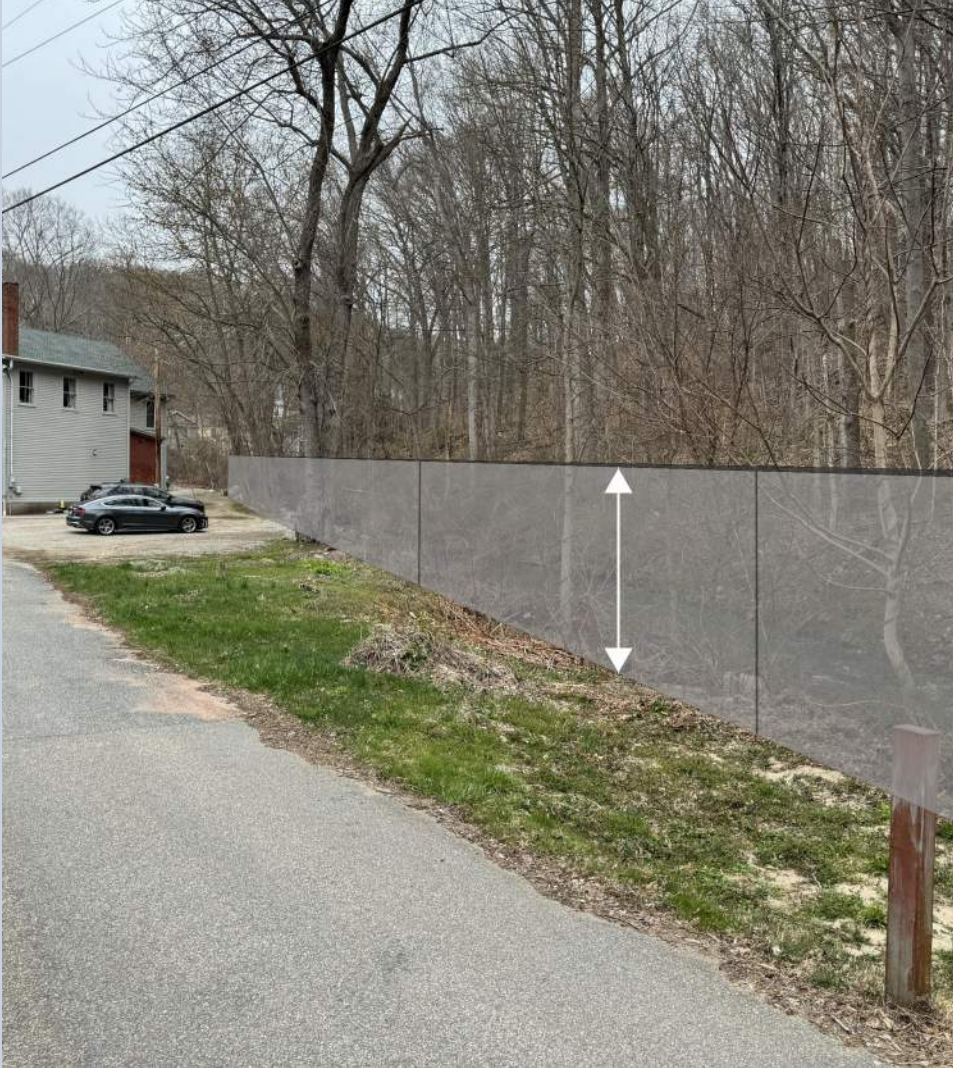
Example Flood Wall

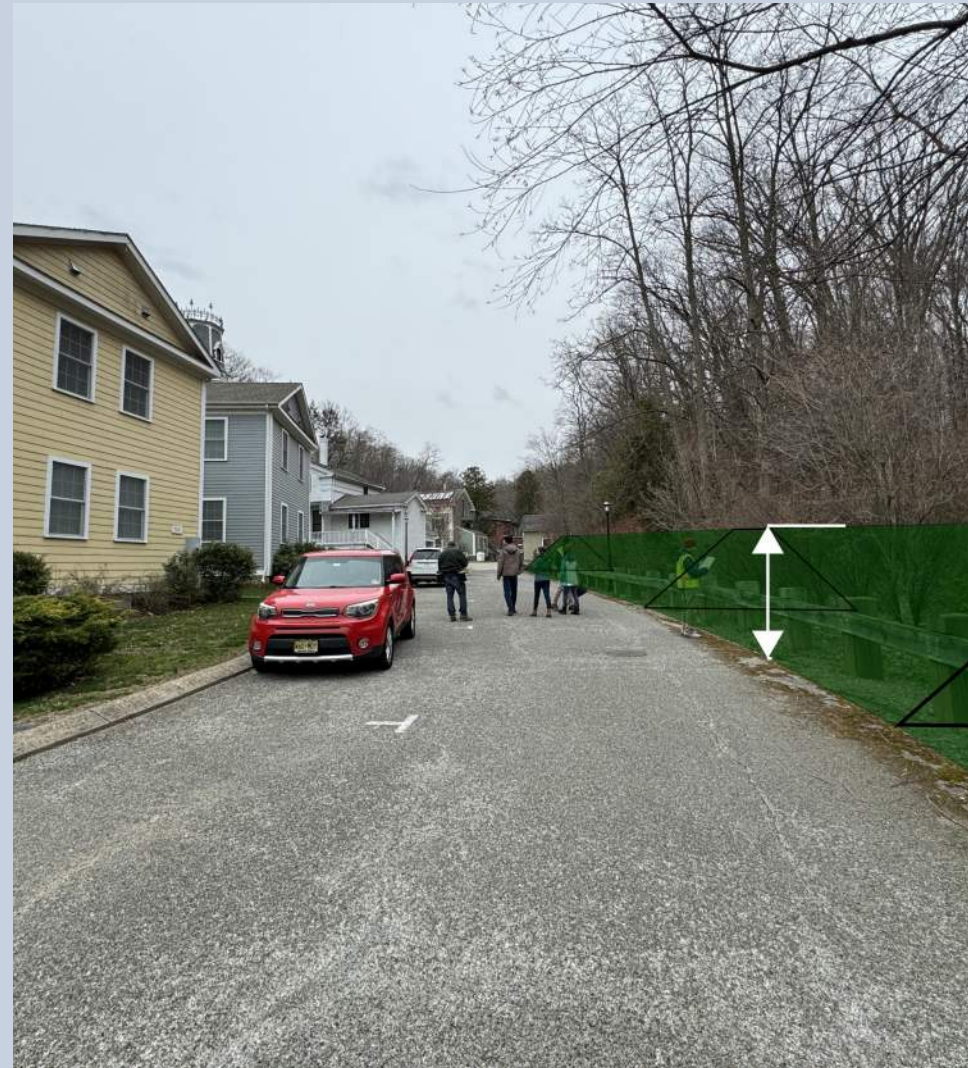
Example Earthen Berm Floodwall

Alternative 3 consists of the improvements in Alternatives 1 and 2, plus additional infrastructure to protect properties on Creamery Road and Norwich Road from the 100-year flood. To achieve this level of protection, Alternative 3 includes construction of a floodwall and earthen berm structure on the right bank of Succor Brook between Norwich Road and Creamery Road. The northern end of the earthen berm would tie into a raised and re-located driveway accessing the Artists Village property on Norwich Road. In the conceptual design, the floodwall would extend from the Creamery Road bridge upstream along the right bank of Succor Brook. The floodwall would transition to an earthen berm near the southeastern corner of the Artists Village property, where more room is available to construct a berm. The conceptual maximum height of the floodwall is 6 feet near Creamery Road, tapering to 4 feet along the earthen berm segment. The purpose of the floodwall and raised driveway would be to prevent flood flows from reaching over the banks of Succor Brook and damaging properties near the Brook.

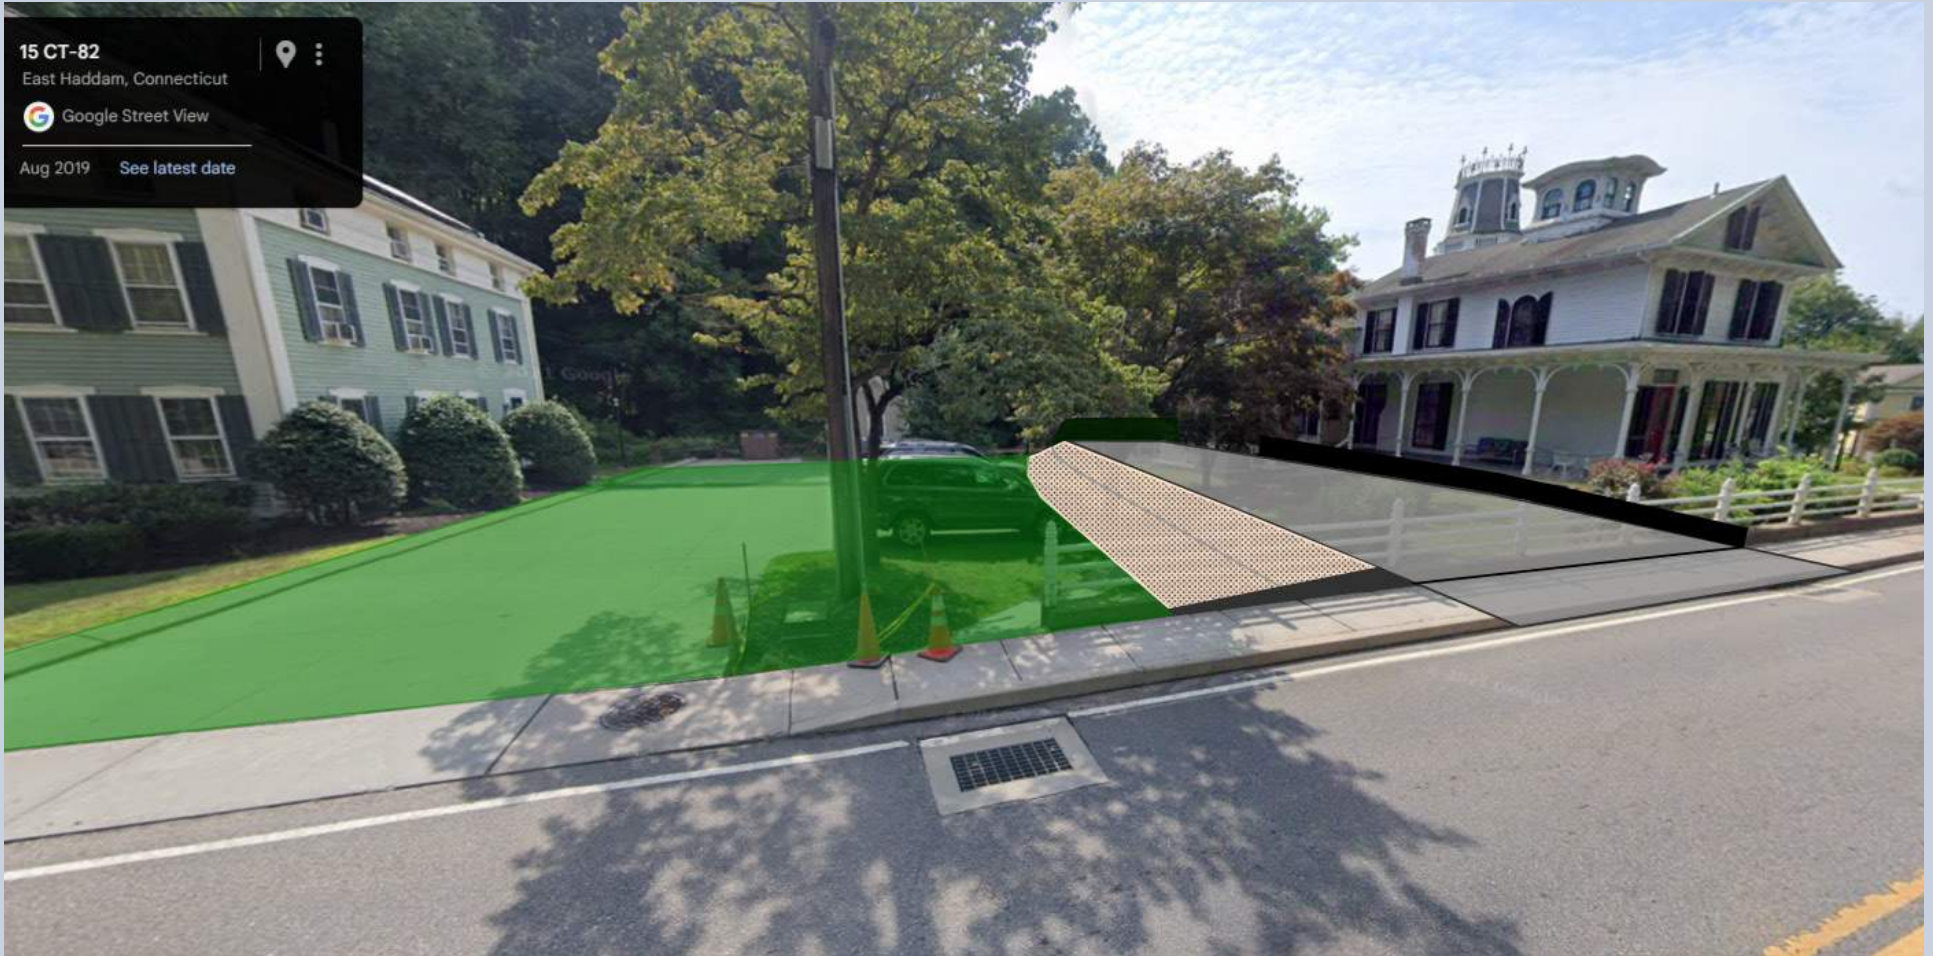
Example Raised Driveway at Norwich Road

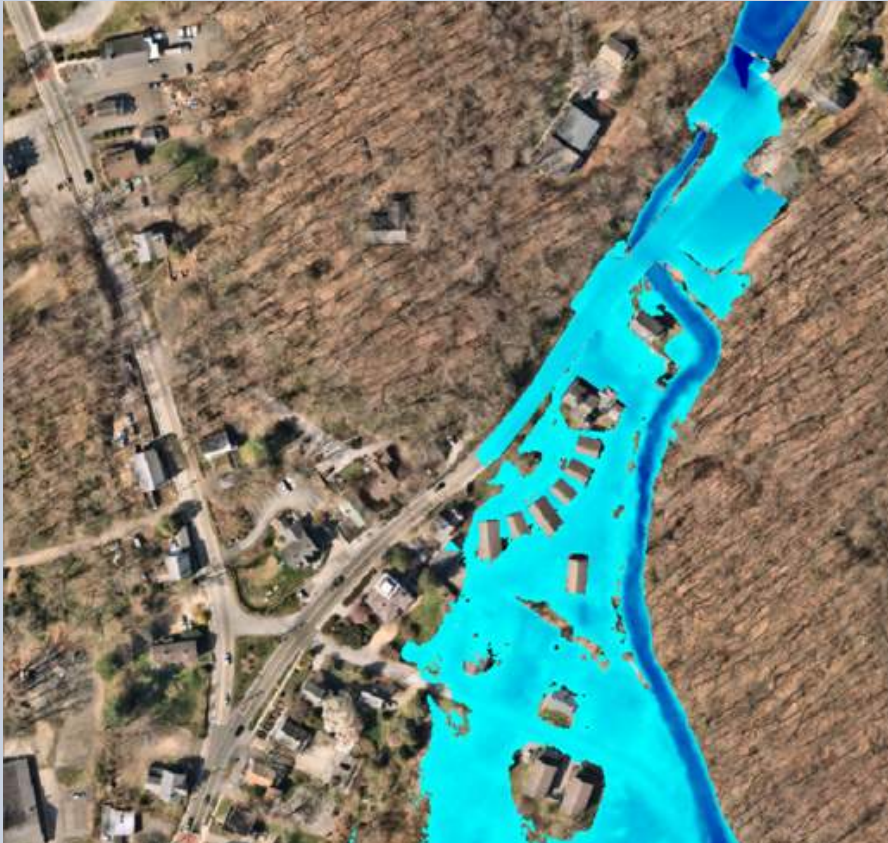
Alternative 4: Remove Rehearsal Studio + Widen Creamery Road Bridge + Construct Dam at Daniels Road Pond + Raise Driveway and Construct Berm/Floodwall

Present-day 100 year flood, no build condition

Kleinfelder reviewed a constructed dam alternative, conceptually sized with a 200-foot spillway and a 36-inch diameter low-flow culvert. The spillway elevation was adjusted such that the maximum elevation in the pond during the present-day 100-year flood was 1 foot below the elevation of Daniels Road. Because bathymetric data for the pond was not available, Kleinfelder estimated the amount of storage by extrapolation of Lidar topography obtained from the CT Environmental Conditions Online database. The estimated storage volume below the crest elevation used for the analysis was approximately 135 acre-feet. With this conceptual dam in place along with the removed Rehearsal Studio and widened Creamery Road bridge, overtopping of Norwich Road in the present-day 100-year flood is predicted to be eliminated without requiring construction of the bypass culvert proposed in Alternative 3. Compared to Alternative 2, the extents and depths of flooding in each event would be reduced further in this alternative.

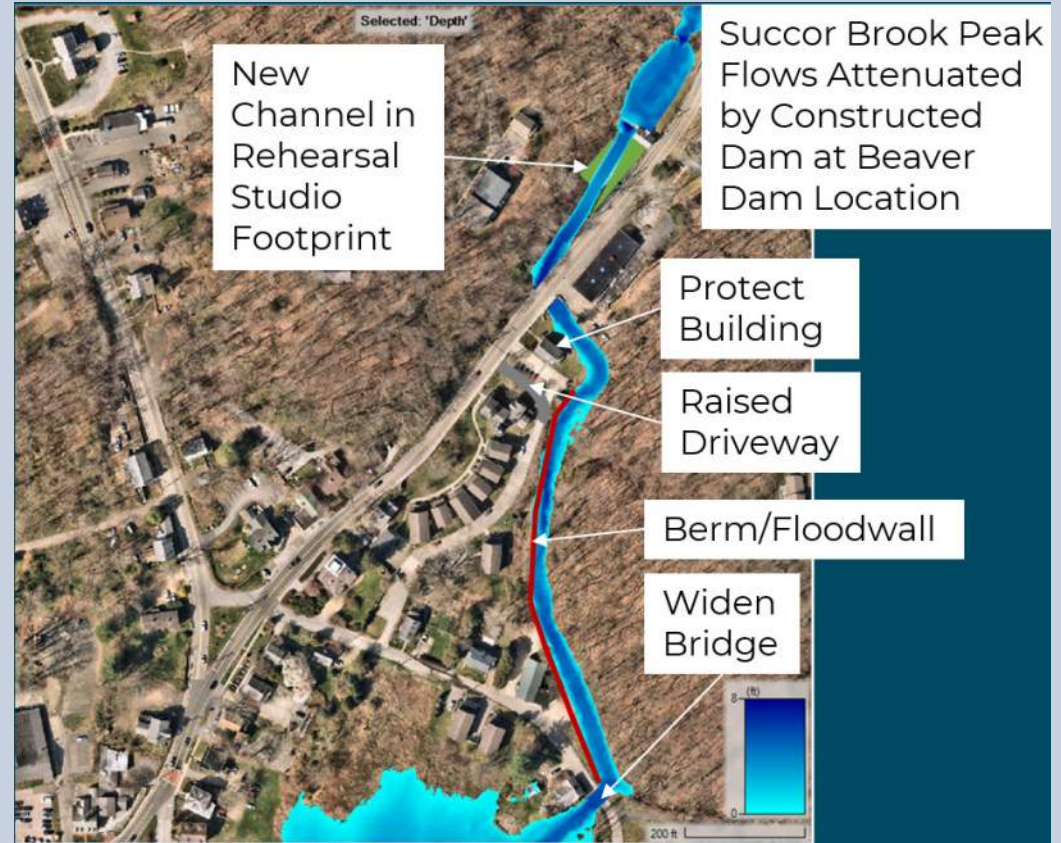
Present-day 100-year flood, with mitigation

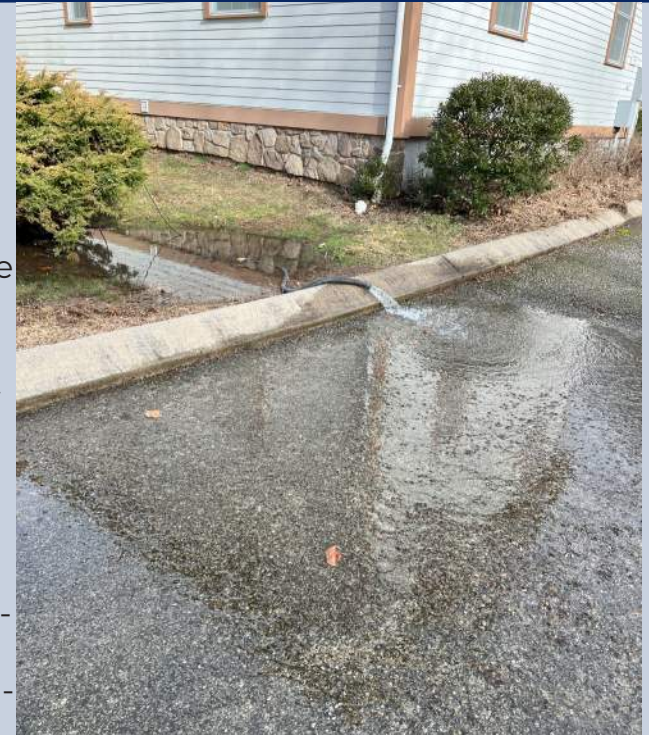
Pumping out a flooded area next to a building

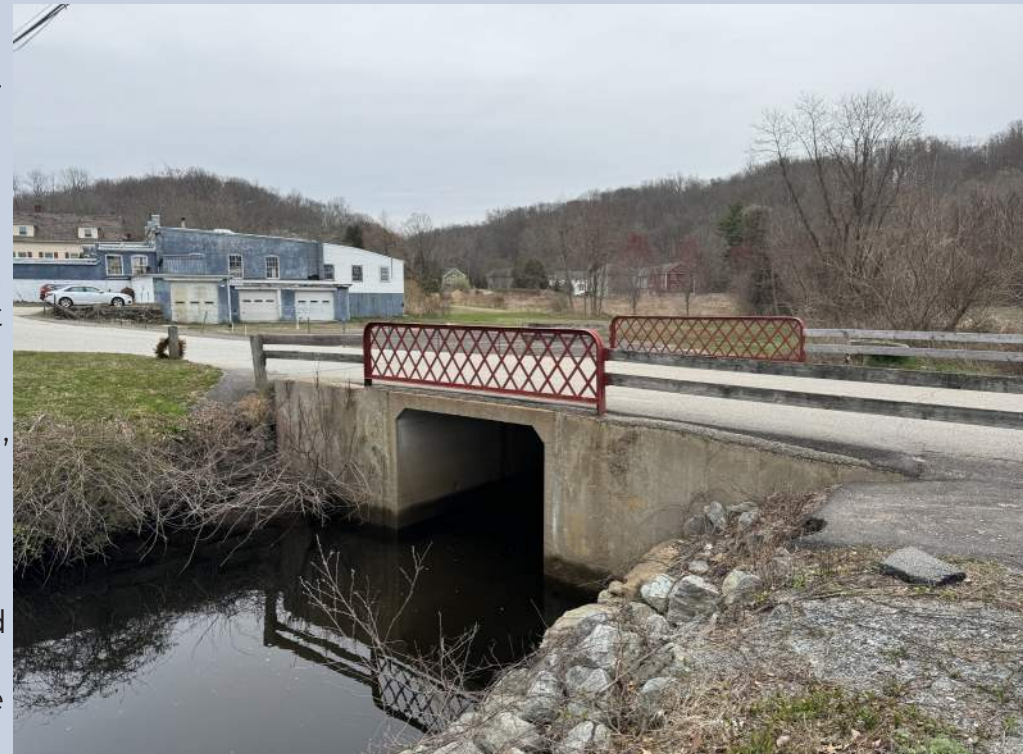
Lumber Yard Road crossing

Kleinfelder found that although the Lumber Yard Road crossing overtops in storms larger than the present-day 10-year storm, replacing the crossing with a wider structure did not significantly change flooding conditions in the flood-prone areas of Norwich Road and Creamery Road. However, the current box culvert at Lumber Yard Road has abutments that extend into the bankfull width of the brook, and replacement of the culvert with a wider structure would provide an opportunity to improve aquatic organism habitat connectivity between Succor Brook and the Connecticut River. In addition, there are potential construction cost savings that could be achieved if the Lumber Yard Road bridge were replaced at the same time as the Creamery Road bridge.

Because of the potential to increase conveyance capacity and improve overall riverine habitat connectivity along Succor Brook, Kleinfelder recommends that future studies to replace the Creamery Road bridge also consider replacement of the Lumber Yard Road culvert.

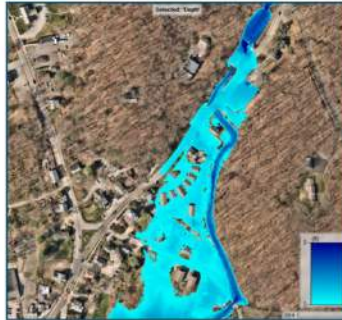
**Flood map
projections for
present-day
100-year flood*
with no
intervention**

*A 100-year flood has a 1% chance
of happening in any given year

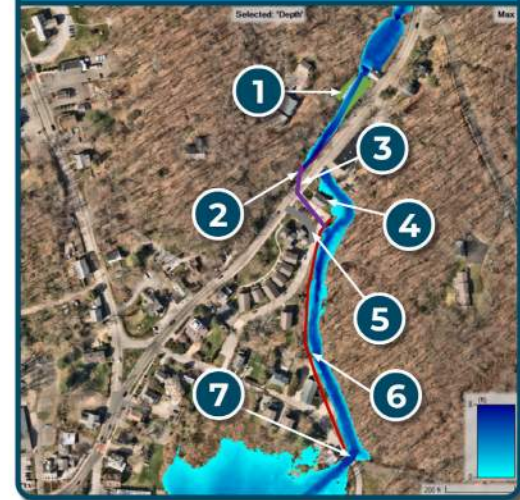
- 1 Remove Rehearsal Studio; Create New Channel
- 2 Extend Headwall
- 3 Install New Drainage Bypass
- 4 Protect Building
- 5 Raise Driveway
- 6 Install Berm
- 7 Widen Bridge

Present-day, 100-year flood, WITH INTERVENTIONS

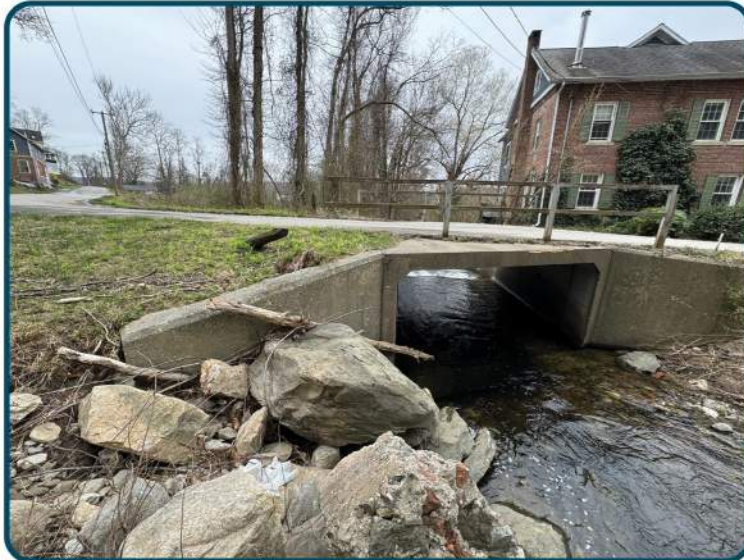
EXISTING BRIDGE CONDITIONS

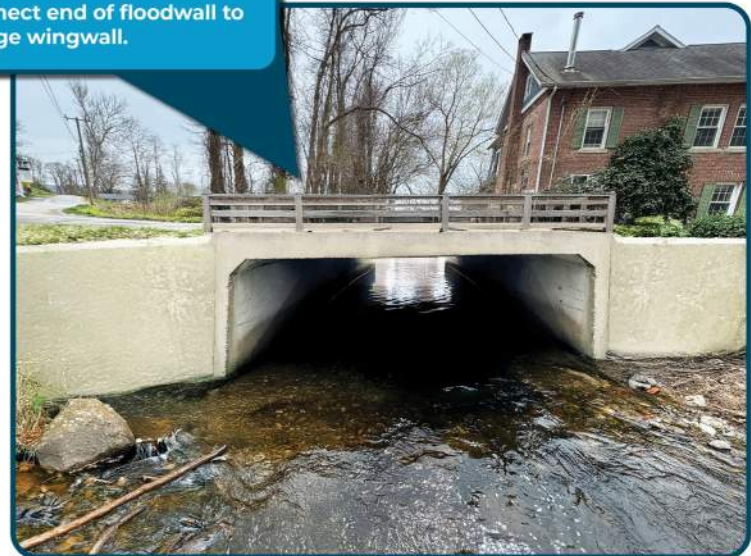
- Replace existing crossing with new 24' wide bridge.
- Restore natural streambed through the bridge crossing.
- Connect end of floodwall to bridge wingwall.

PROPOSED BRIDGE MODIFICATIONS
